Manhole Inspection Summary

Manhole # S17KK_002MH

Insp Date: **6/7/07 9:51 AM**

Location Address: **2047 RUXTON AVE**

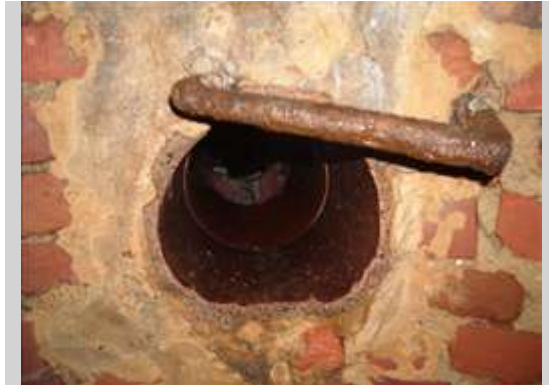
Pipe In @ 8 O'Clock

Pipe Height: **8.4** (in.) Rod and Bar (Angled)
Pipe Material: **Clay** ☐ Pipe Lined
Invert Depth: **12.11** (ft.) Flow Characteristics: **Slow**
Deposits: ☒ **None** ☐ Mud ☐ Sludge ☐ Debris ☐ Grease
Silt Depth: (in.) Deposits Extent:
Infiltration: **None** Pipe Seal Cond: **Sound**
